FINAL PRELIMINARY ASSESSMENT REPORT FOR AQUEOUS FILM-FORMING FOAM AREAS AIR FORCE PLANT 44 TUCSON, ARIZONA

Contract No. W9128F-15-D-0028 Task Order 0003

April 2018

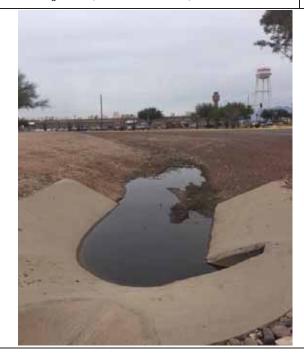
Description:

Outfall and drainage ditch that exits the facility to S Nogales Highway.

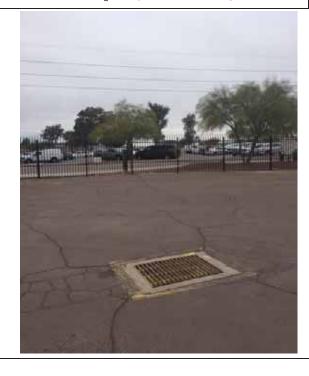
Description:

Fire Engine Wash area storm drain immediately south of Building 828.

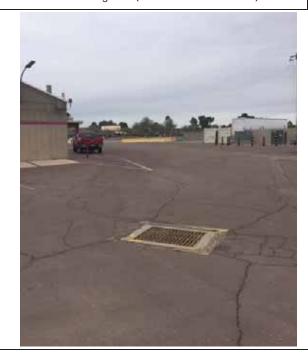
Description:

Fire Engine Wash area storm drain immediately south of Building 828.

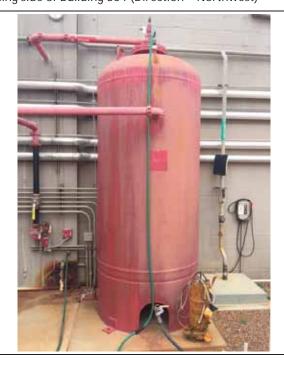
Description:

AFFF Tank that supplies fire suppression system at Building 864 Fuel Barn.

A vertical above ground steel holding tank that supplies AFFF to the fire suppression system is located outside the east side of Building 864 (see Appendix C for photographs). RMS personnel explained that monthly tests of tank pressure and volume are performed on the tank. There are no records that AFFF was released during the tests (note that the hoses shown in Photographs A4 and A5 in Appendix C are connected to the bladder pressure system and not to an AFFF outlet. According to Raytheon Facilities Management, there are no records of any pressure tank failures. However, the frequency of pressure tank testing was not specified. By design, AFFF is prevented from being released to the environment because the hoses are connected to the bladder pressure system, and not to the bladder containing AFFF. Replenishment of the AFFF holding tank after testing is from supplies stored at the Building 836 Chip Yard (Section 4.4.3). Replenishment is accomplished by pumping AFFF into the system from totes that have been transported from the Building 836 Chip Yard. Ayuda did not observe any evidence of spills at this location, such as staining, puddling, or slick surfaces due to residual AFFF. Although there was no evidence of a spill or records to support this evidence, it is possible that AFFF has been released to the environment during system testing. The Building 864 Fuel Barn, AFFF holding tank, and sump are shown on Figure 1-2.

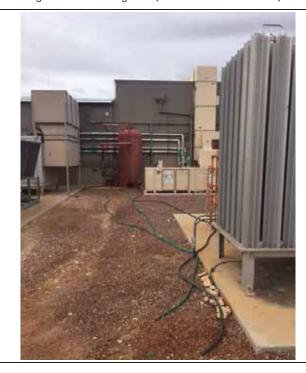
Description:

By design, there is no way that AFFF can be released to the environment by these connected hoses, as they are not connected to the bladder containing AFFF. All AFFF valves are secured and locked.

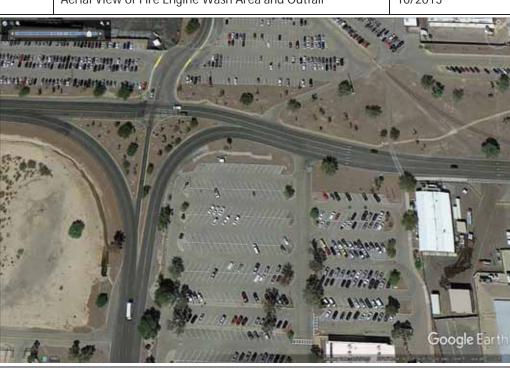
Description:

Aerial View of the Fire Engine Wash Area and Fire Engine Wash Outfall. Google Aerial Image capturing washing of the fire engines at AFP 44.
